INTERIM REPORT OF EXPERIMENTAL CRACK
SEALING IN ASPHALTIC CONCRETE
PAVEMENTS, THULE AIR BASE, GREENLAND
8-24 AUGUST 1960

MISCELLANEOUS PAPER NO. 4-436

July 1961

U. S. Army Engineer Waterways Experiment Station
CORPS OF ENGINEERS

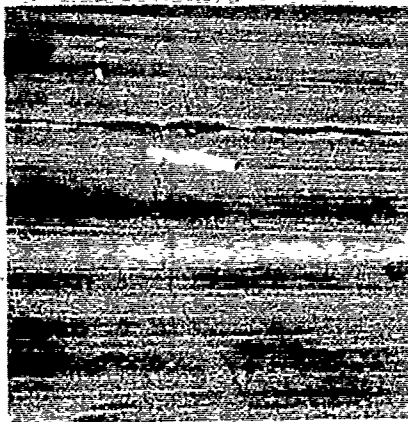
Photograph 1. Crack No. 1 on runway location prior to sealing. This was a very narrow, hairline-type crack.

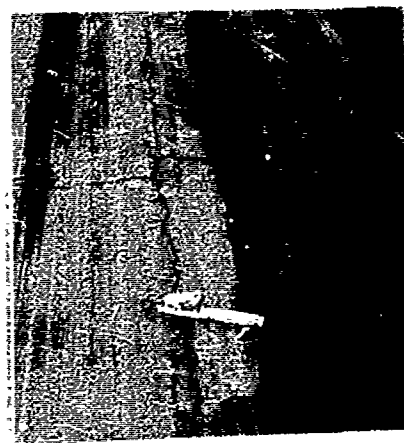
Photograph 4. Crack No. 5 on runway location prior to routing. This was a medium crack $1/3$ to $1/4$ in. in width.

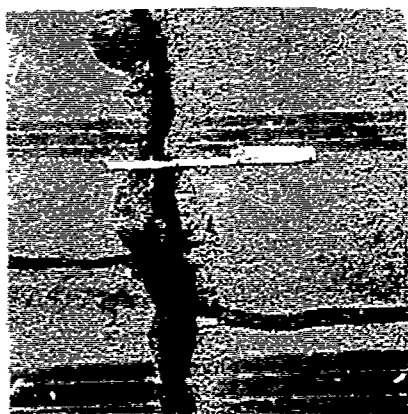
Photograph 15. Crack No. 6 on runway location before routing showing extent of previously applied sealing material.

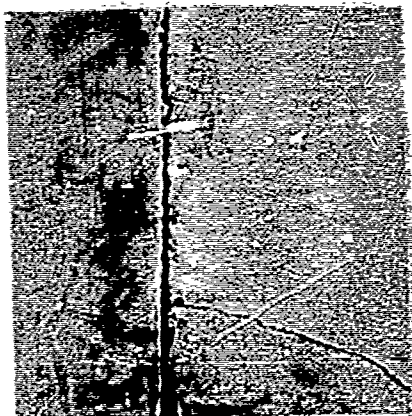
Photograph 17. Typical condition of crack, previously filled, prior to use of infrared heater.

had been previously sealed where the sealing material had hardened and had come loose from the sides of the crack. The heater softened the old sealing material, both in the crack and the excess on the surface, which would then flow into and reseal the crack (photographs 16 through 20). This operation could be performed very rapidly and appeared to be very effective.

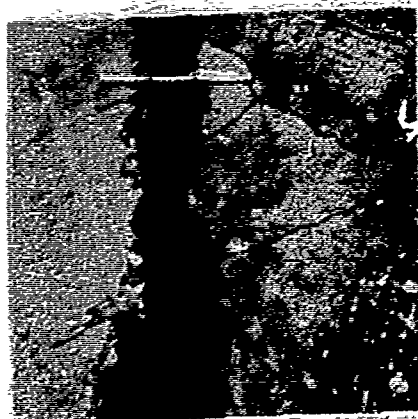
Photograph 18. Effect of infrared heater on old cracks previously sealed with AP-1 asphalt cement.

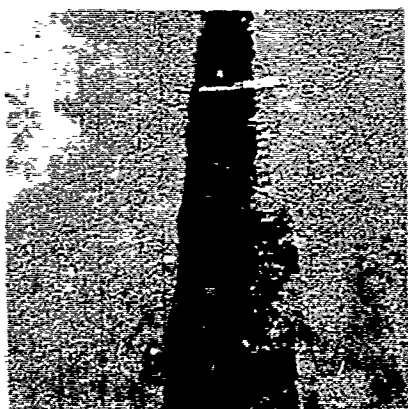
Photograph 19. Previously sealed crack after use of infrared heater.

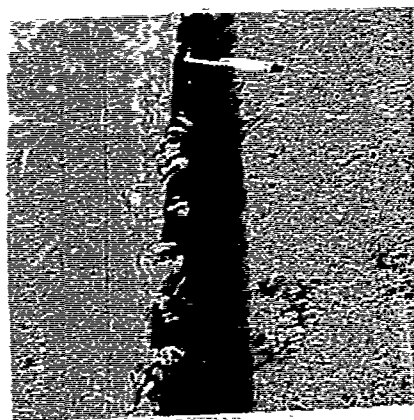
Photograph 20. Unprepared crack, previously filled, heated with infrared heater and sealed with Allied material.

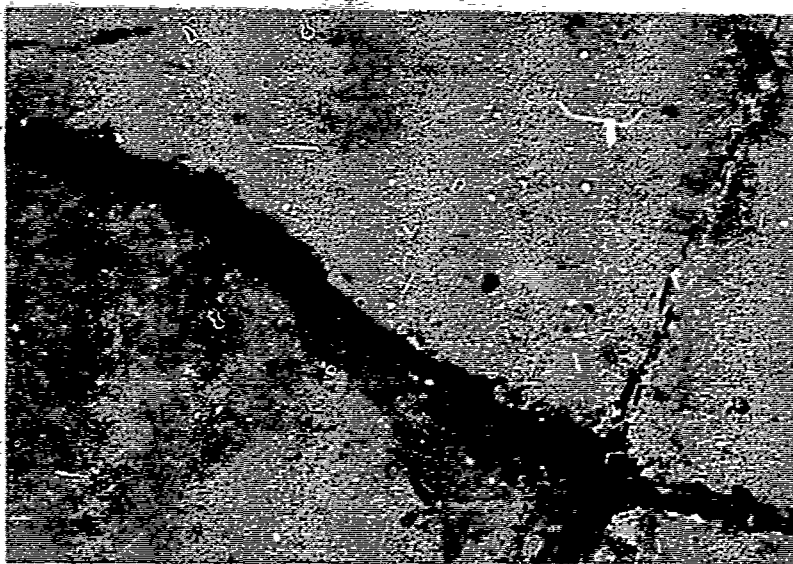
27. The AM and PP materials remained soft and pliable, with the AM probably being a little softer, and neither gave any indication of stripping loose. Both showed good adherence, even under the impact of landing aircraft.

Photograph 25. Allied material in track No. 1 on
northeast work-up apron.

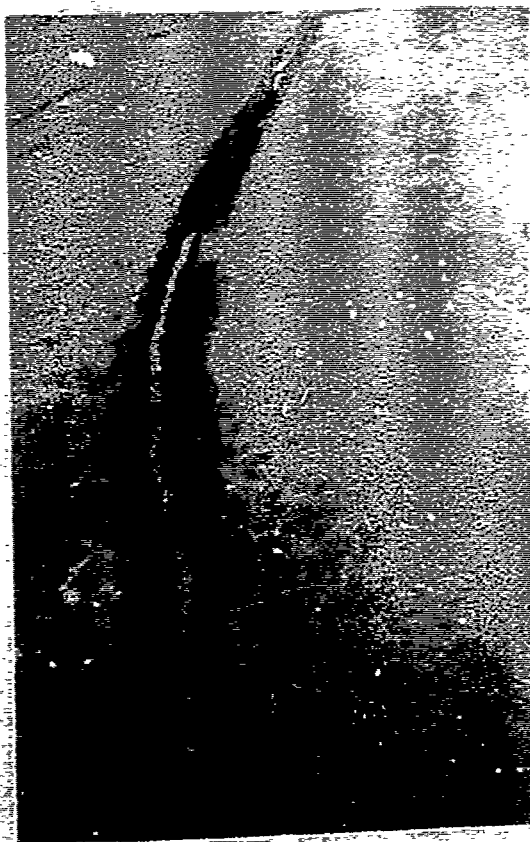
29. The CPS remained very soft longer than did the other materials, some areas requiring as much as 36 hours to set up in the existing weather conditions. During this period, the material was sometimes splattered out of the groove by tires of landing aircraft, as indicated in photographs 28, 29, 36, and 37. After set had occurred, the CPS was somewhat soft and appeared to have about the same consistency as the AM and PP materials. There was also some indication that it could be pulled by hand from the cracks.

Photograph 26. Coast Pro-
Sent in track No. 16 on
northeast work-up apron.
